COMMISSION OF  
INQUIRY INTO THE  
AIR ONTARIO CRASH  
AT DRYDEN, ONTARIO

Final Report

Technical  
Appendices

The Honourable Virgil P. Moshansky  
Commissioner

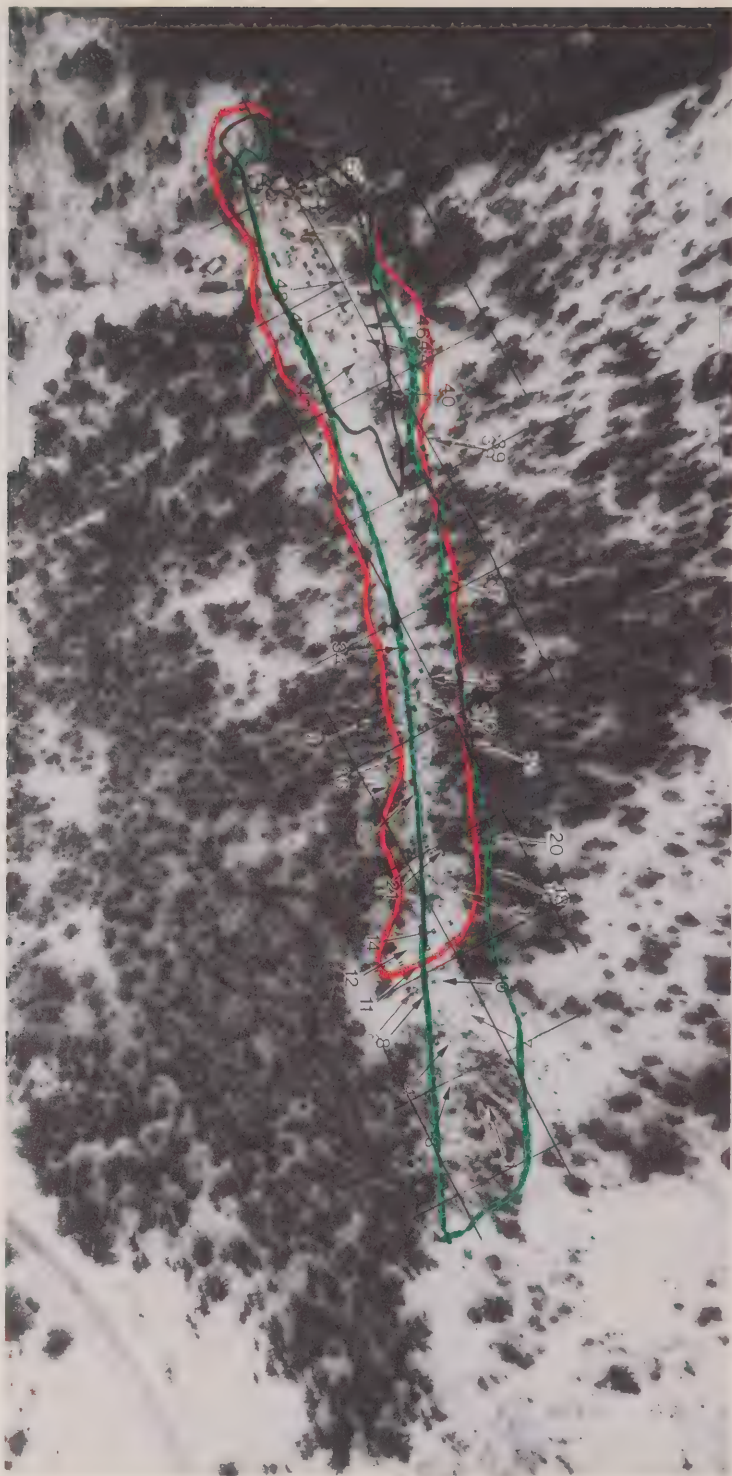
- Figure 6 - Aerial photograph of main wreckage trail with overlays showing the tree cut swath, tree fire damage, left wing and left elevator wreckage distribution, and the main and nose landing gear doors wreckage distribution.

Overlay 1: Tree Cut Swath

Overlay 2: Tree Fire Damage

Overlay 3: Left Wing and Left Elevator

Overlay 4: Main and Nose Landing Gear Doors

- 3.6 Sections of all the major control surfaces were accounted for at the wreckage site between the top of the knoll and where the aircraft finally came to a stop. Found along the wreckage trail were sections of the left elevator, the left inboard and outboard flaps and sections of the flap leading edge vanes, the flap shroud doors, the left aileron and trim tab, and lift dumpers 3, 4, and 5 from the left wing. The remaining control surfaces, including the majority of the right wing were found still attached to the fuselage structure, or in close proximity to the main wreckage. Figure 6 shows an aerial photograph of the main wreckage trail with overlays depicting the outline of the tree cut swath (overlay 1), an outline of the tree fire damage (overlay 2), location of wreckage items identified as coming from the left wing or left elevator (overlay 3), location of wreckage items identified as coming from the main and nose landing gear doors (overlay 4).

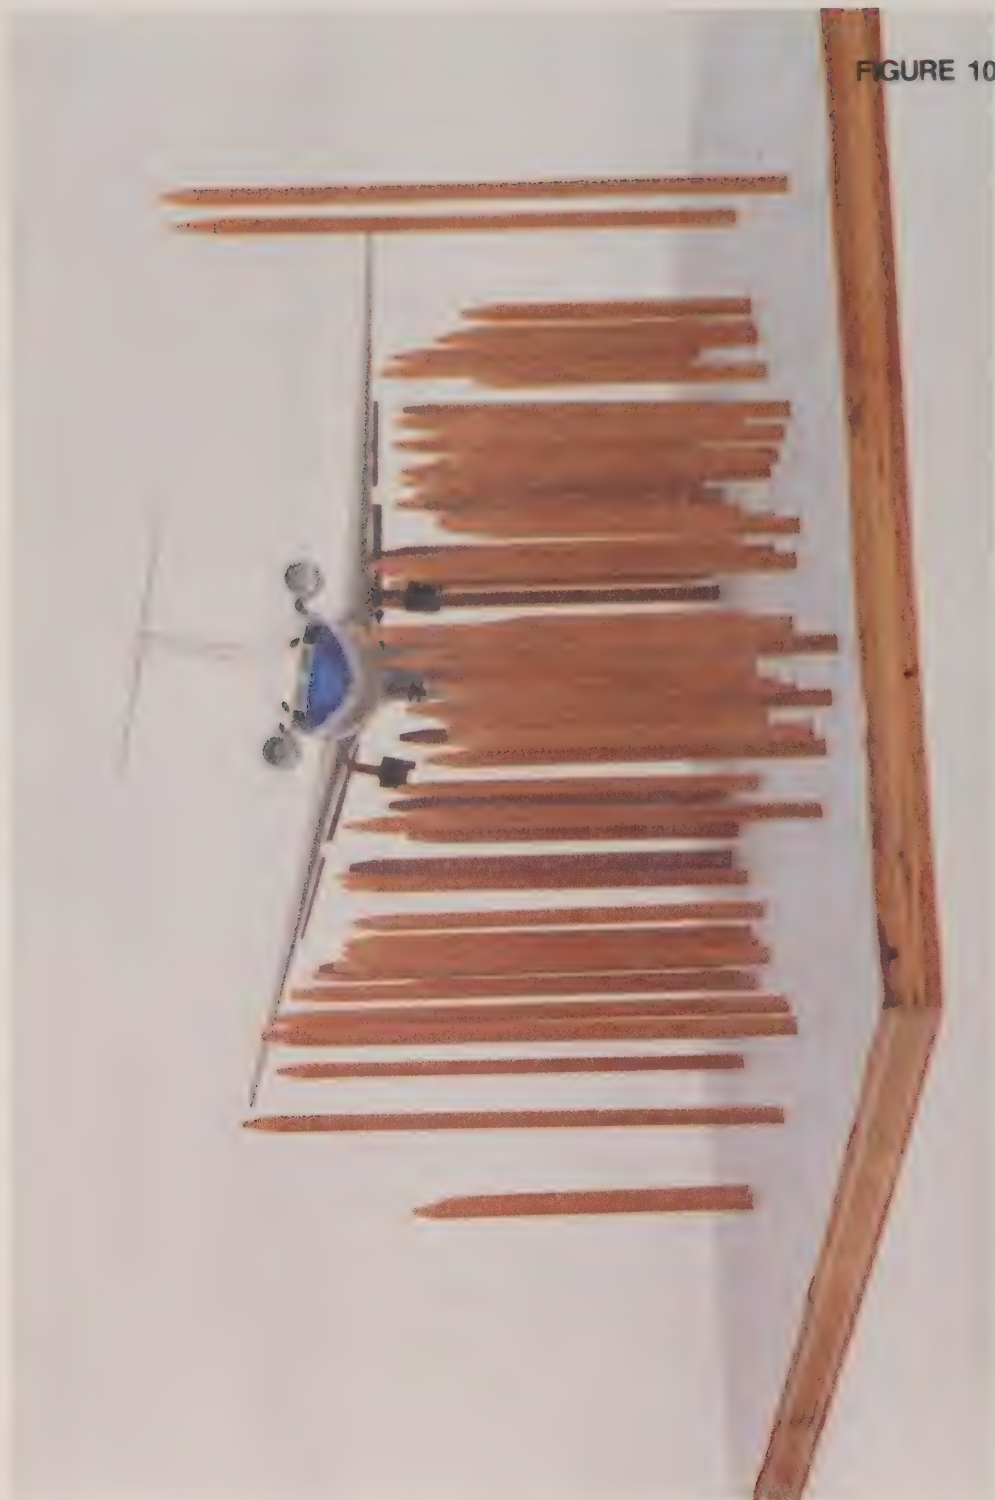
Figure 11- Infrared aerial photograph looking back along the wreckage trail towards the airport. The extent of the fire damage to the trees is represented by the darker coloured trees.

The initial pieces of wreckage that exhibited fire damage, were items number 11, outboard wing leading edge and number 12, LH piece outboard wing structure containing a hot-air anti-ice exhaust louvre and part of the fuel tank (Appendix 'A'). Both items were found in close proximity to each other on the left side of the wreckage trail approximately 50 m from the first major tree strikes near the top of the knoll. Both items exhibited small areas of superficial charring and sooting and were adjacent to burnt trees. The remaining pieces of wreckage from this point forward until the main wreckage all exhibited some form of burn damage such as charring or sooting. It appears that as the left wing started to break apart fuel was lost and was ignited almost immediately. The ignition point of the fuel was not determined but may have been the result of electrical arcing as the wires in the wing were torn out or by fuel vapours being ignited by the engines. The ensuing fire traveled or followed the aircraft path until the aircraft finally came to rest. The post crash fire was confined to the trees down and adjacent to the wreckage trail with many of the trees exhibiting superficial charring. Figure 11 is an infrared aerial photograph showing the wreckage trail looking back towards the airport. The use of infrared photography clearly displays the fire damage to the trees as depicted by the outline of darker coloured trees.

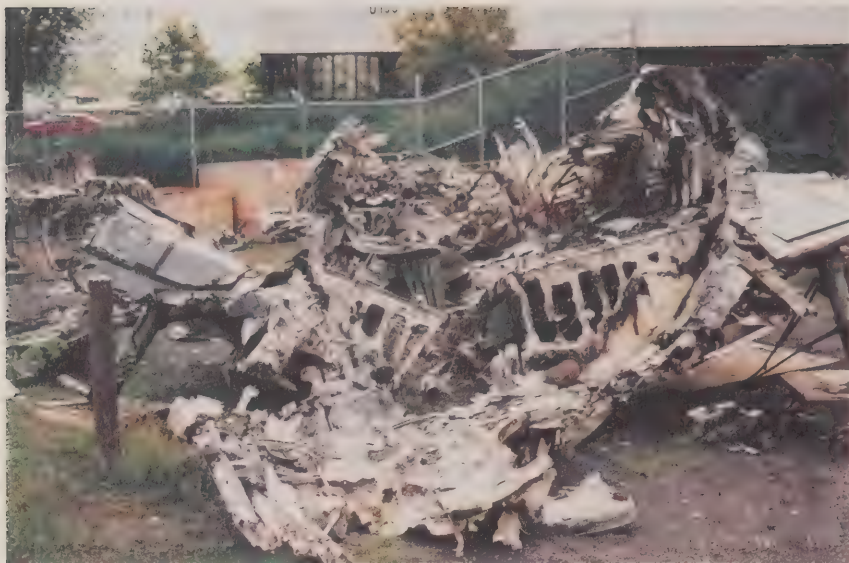
**Figures C-1, C-2**

**Fuselage view from rear showing burnt out cabin area.**

The fuselage from the interior of the cockpit back to the rear pressure bulkhead was gutted by post crash fire. Although the fuselage was gutted the fire appeared to have been more intense on the left side than the right. This is based upon the observation that part of the right side of the fuselage (containing the overwing exit and nine windows) was still in place and the exterior paint scheme, although charred, was still recognizable. The exterior nose of the aircraft was relatively free of fire damage. The cockpit floor was burnt away revealing the remains of the nose gear and steel belts from the tires. The left side of the instrument panel was completely burnt out whereas the centre (engine panel) and right panel were relatively intact although they were also burnt and physically damaged. The engines, tail section and empennage exhibited superficial sooting and the interior of the tail section was in good condition.

All of the wreckage was sorted and a partial reconstruction of the major pieces was carried out. In this manner, the break-up patterns and fire damage could be examined, and all major components of the fuselage and wings could be identified. The tail section was essentially intact, and although the cockpit area was gutted due to post-impact fire, it was roughly in one main piece. A general photo of the burned out cabin area of the fuselage is shown in Figure C-1.

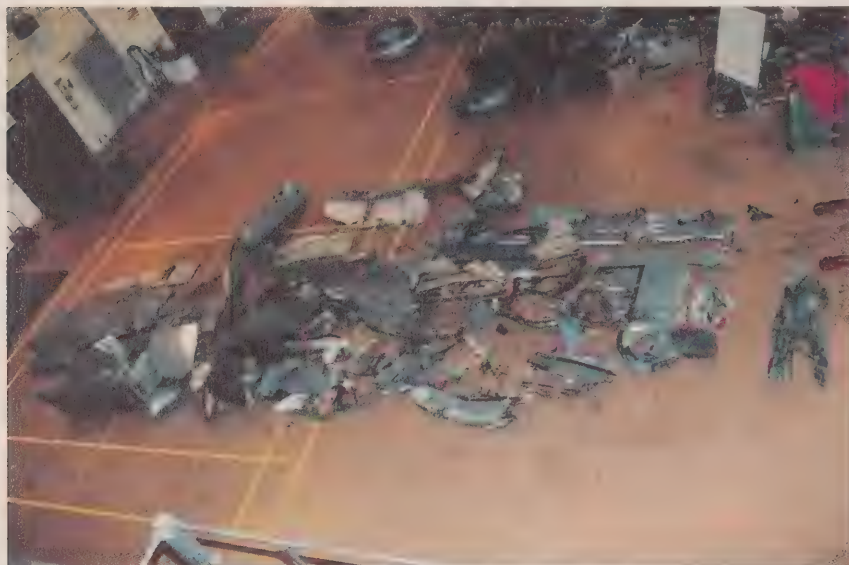
**Wreckage of left wing laid out during reconstruction**

- 3.5 A review of the wreckage distribution shows that as the aircraft proceeded through the trees, it shed most of its left wing in the upper half of the wreckage trail, due to impact damage with trees. Near the top of the knoll, on the left side near the start of the wreckage trail, the left wing tip navigation light holder and a small piece of the red lens were found. Only the stub section of the left wing inboard from lift dumper (spoiler) #2, remained attached to the fuselage structure after the aircraft came to a stop. The lift dumpers are numbered 1 to 5 on each wing from the inboard end outward.

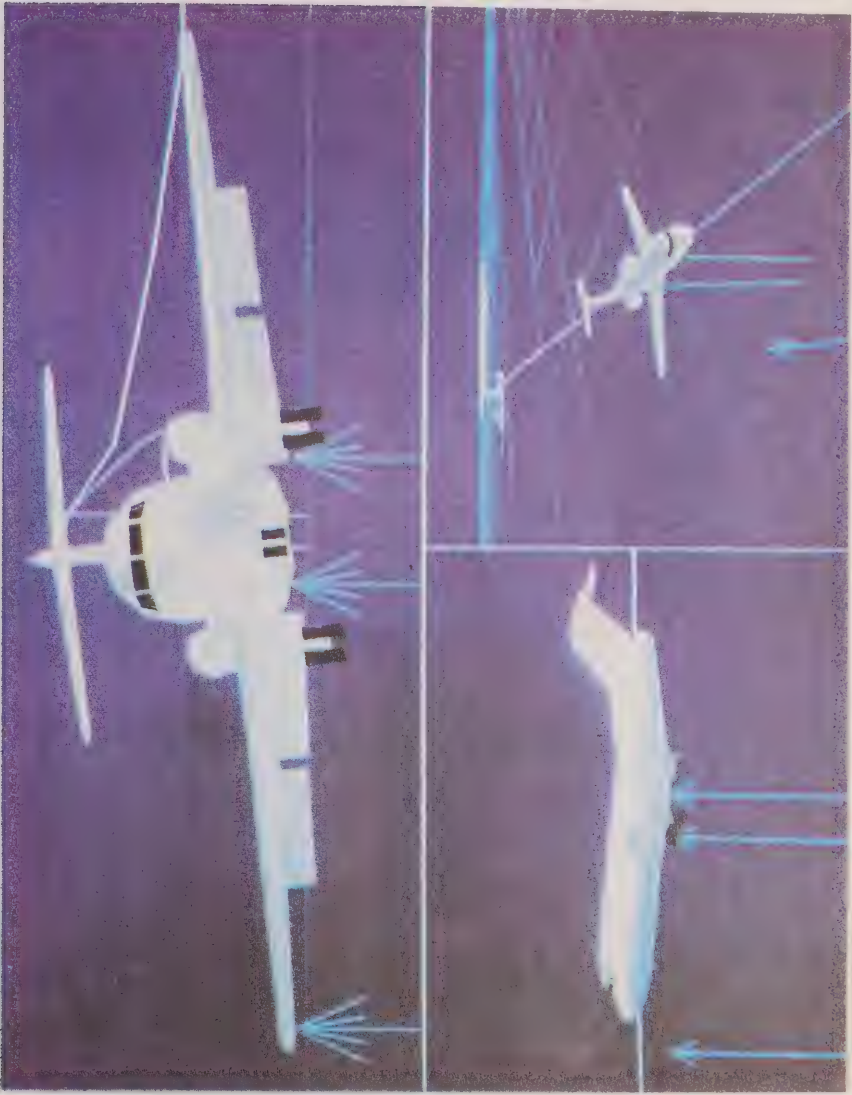
Figure 5 - Fit at location 3.

4.2 The attitude of the aircraft as it passed through the eighteen trees prior to the major tree strike was reconstructed using computer modeling to scale of the aircraft and the cut trees. Appendix 'D' depicts the aircraft attitude at the various locations along the flight path. The flight path was estimated based on the location of the first pieces of wreckage found (rotating beacon red lens) and the possible positions of the aircraft required to strike all eighteen trees. The assumption was made that the aircraft was not yawed, that is, its heading and ground track remained essentially constant. The accuracy of the aircraft attitude varies with the number of trees cut at any one time and the attitudes depicted are considered to be the best possible fit.

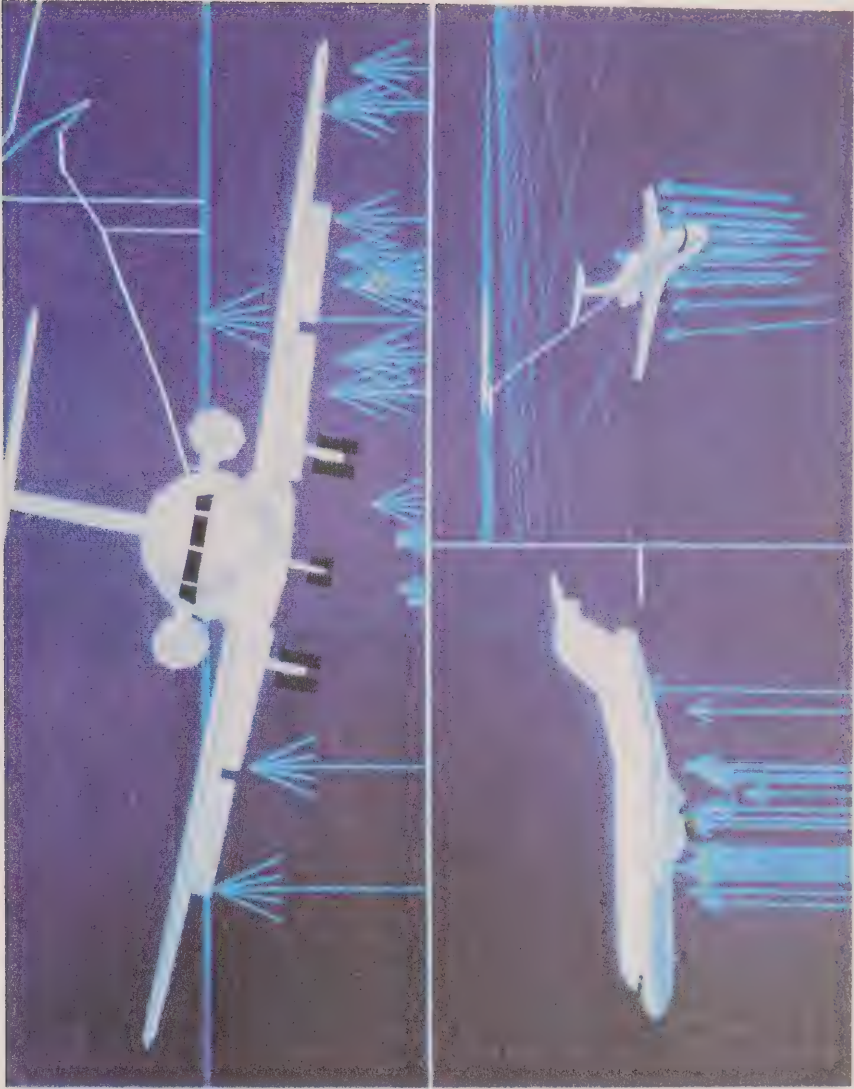
Figure 7 - Fit at location 5.

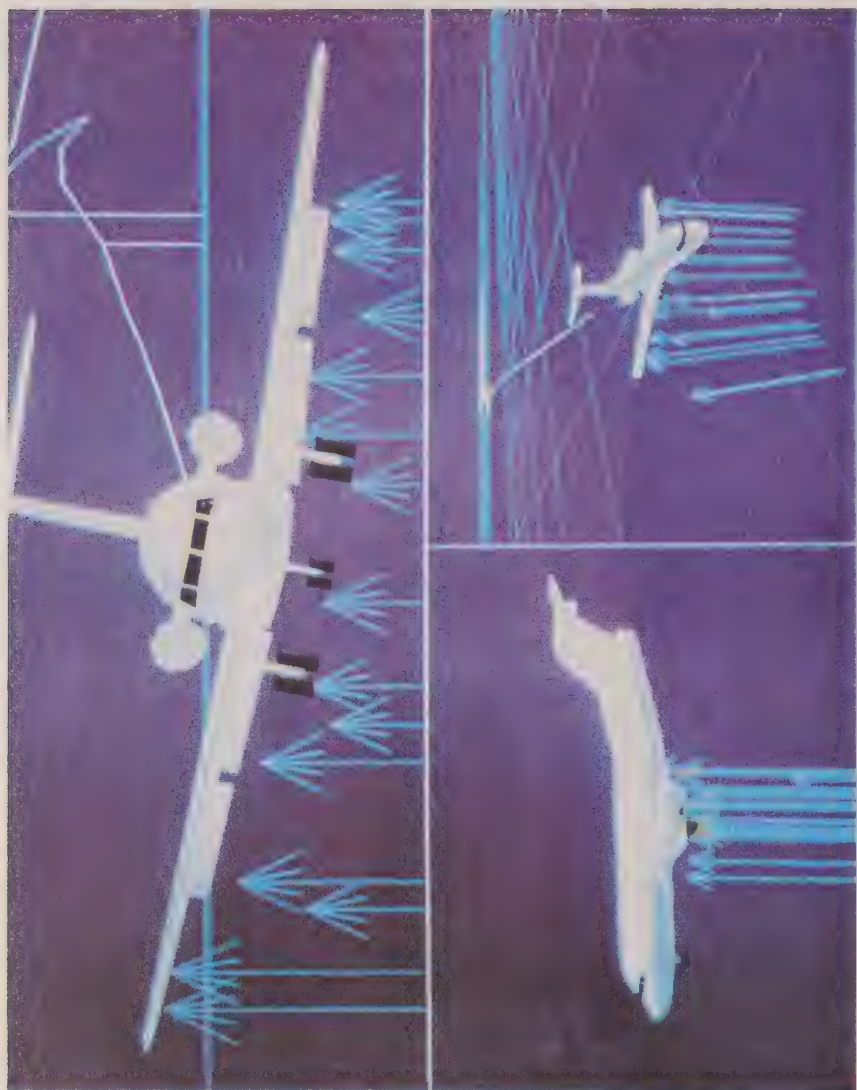
Figure 8 - Fit at location 6.

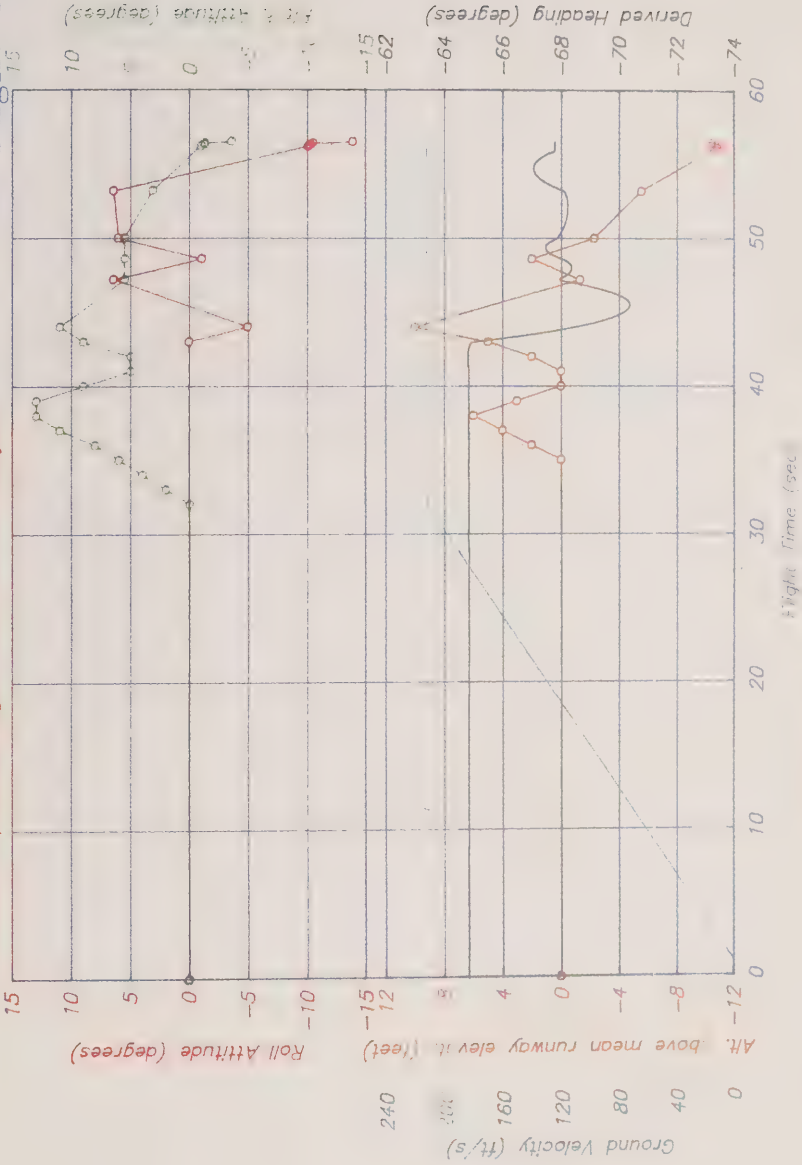
Figure 10: CFONF flight data

# CFONF Estimated Velocity, Heading, Attitude and Altitude vs. Flight Time

- based on previous flights and tree-cut analysis

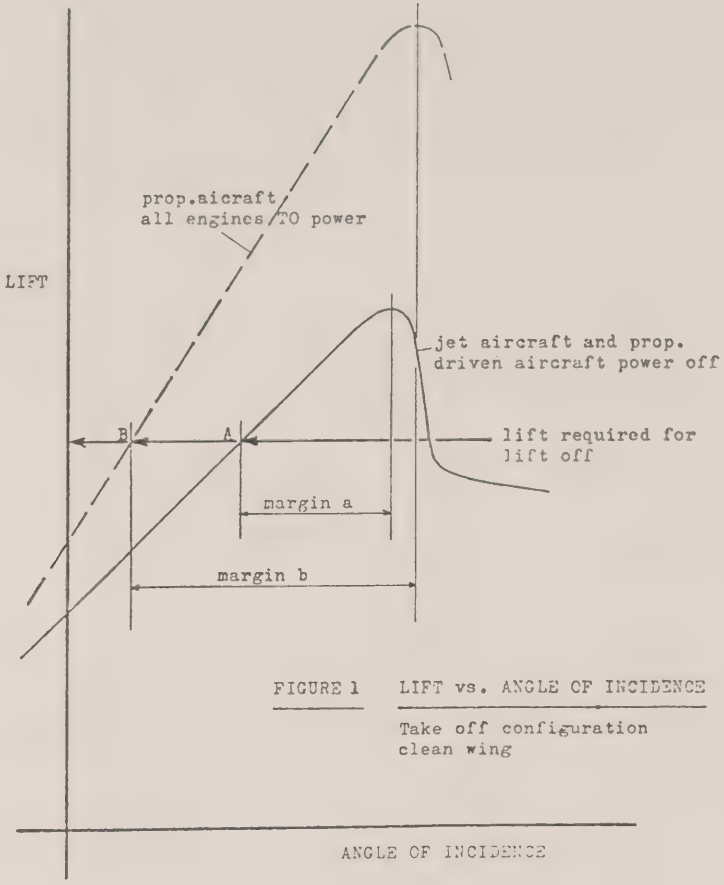
FIGURE 1 LIFT vs. ANGLE OF INCIDENCE  
Take off configuration  
clean wing

In the interest of flight safety complete removal of relatively thick layers of snow and ice from wing and tail surfaces is very common. However, also sandpaper-like roughness caused by thin deposits due to frost or light freezing rain must be completely removed prior to take-off, in particular of jet propelled aircraft.

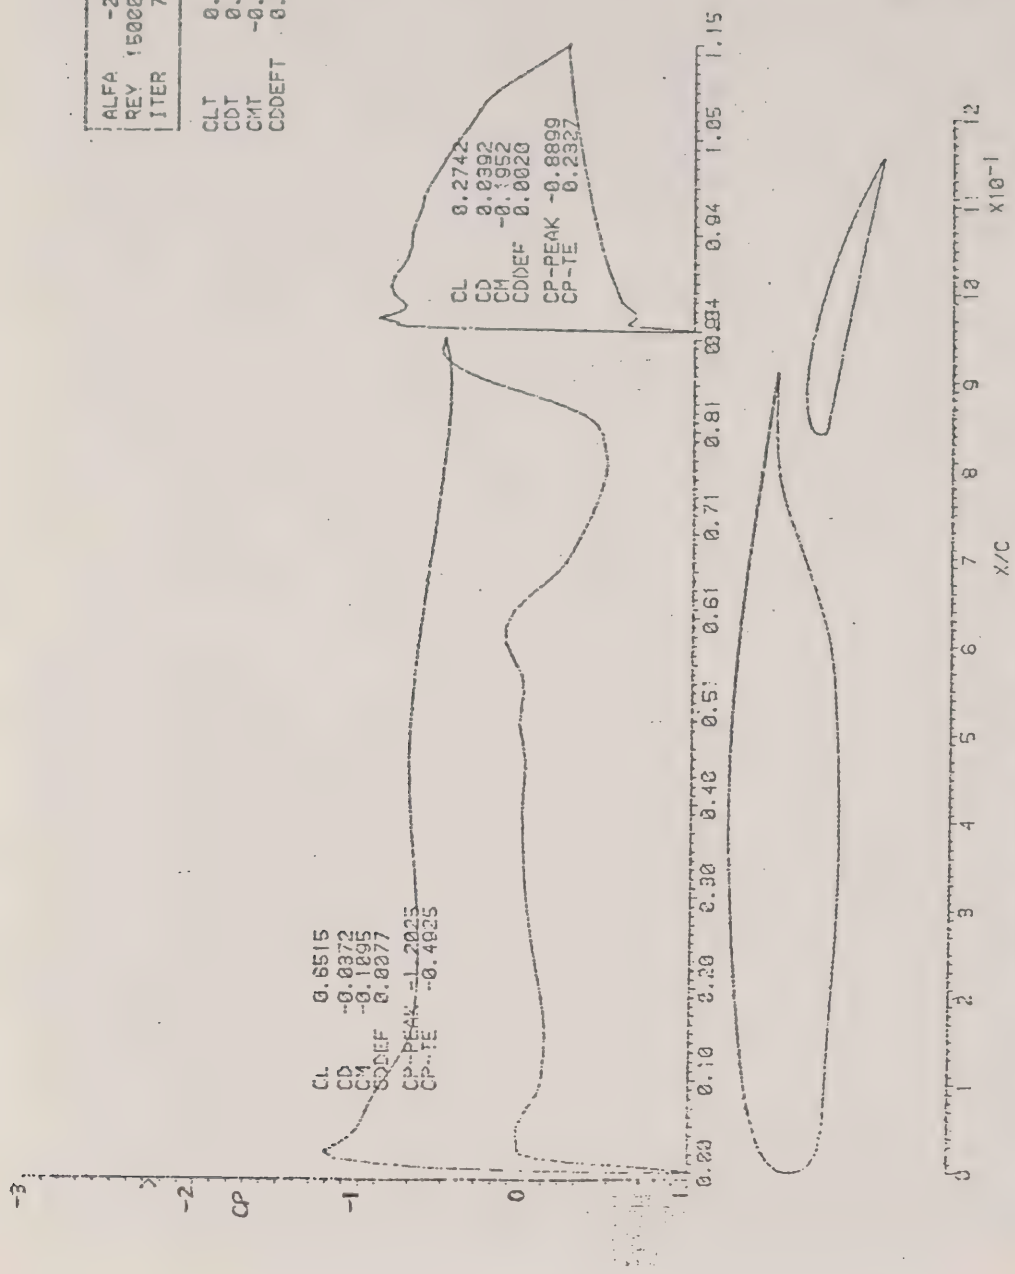
Figure 10a

Section 2 FIGURE 10a Theoretical Flow and Pressure Data for F-28 Aerofoil

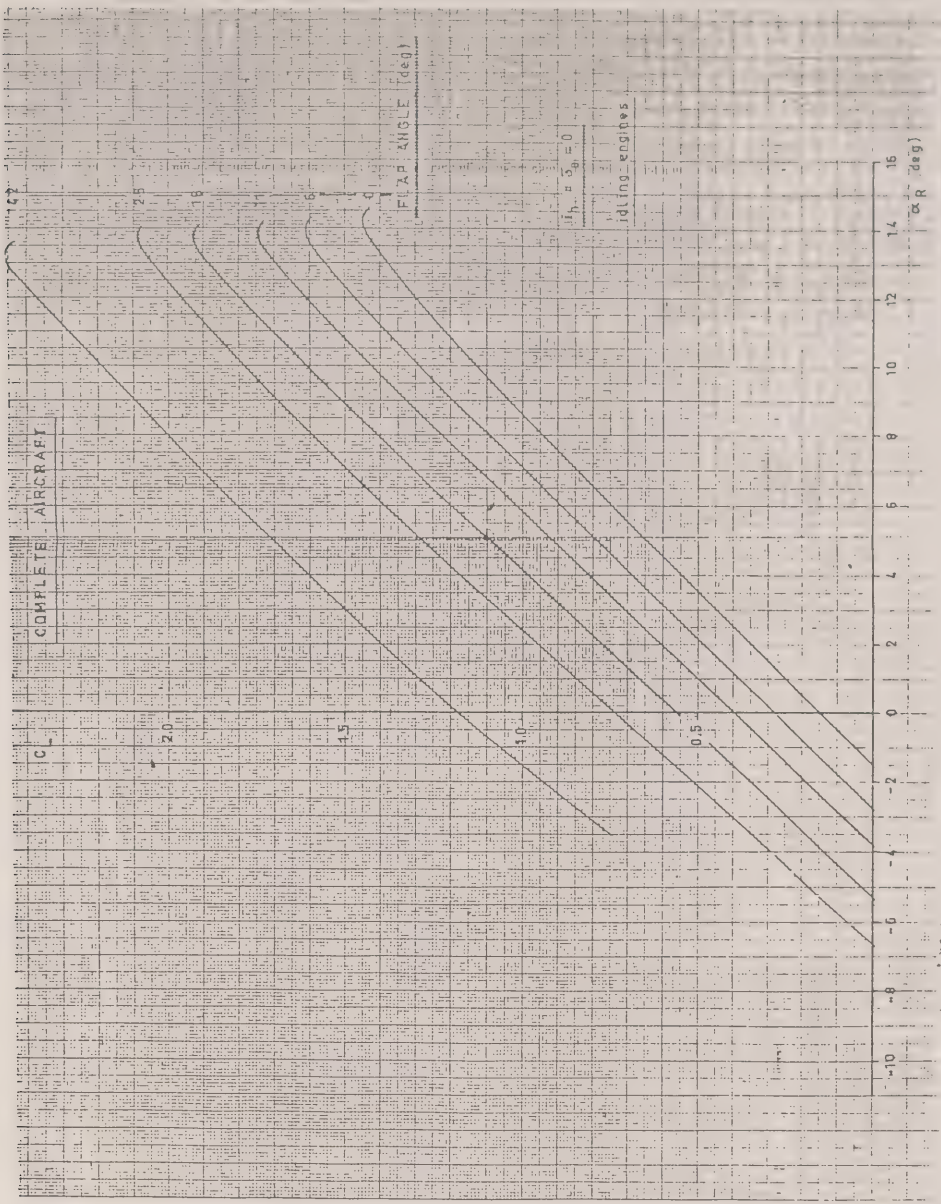
FIGURE 11 F-28 LIFT COEFFICIENT vs ANGLE OF ATTACK (FREE AIR)

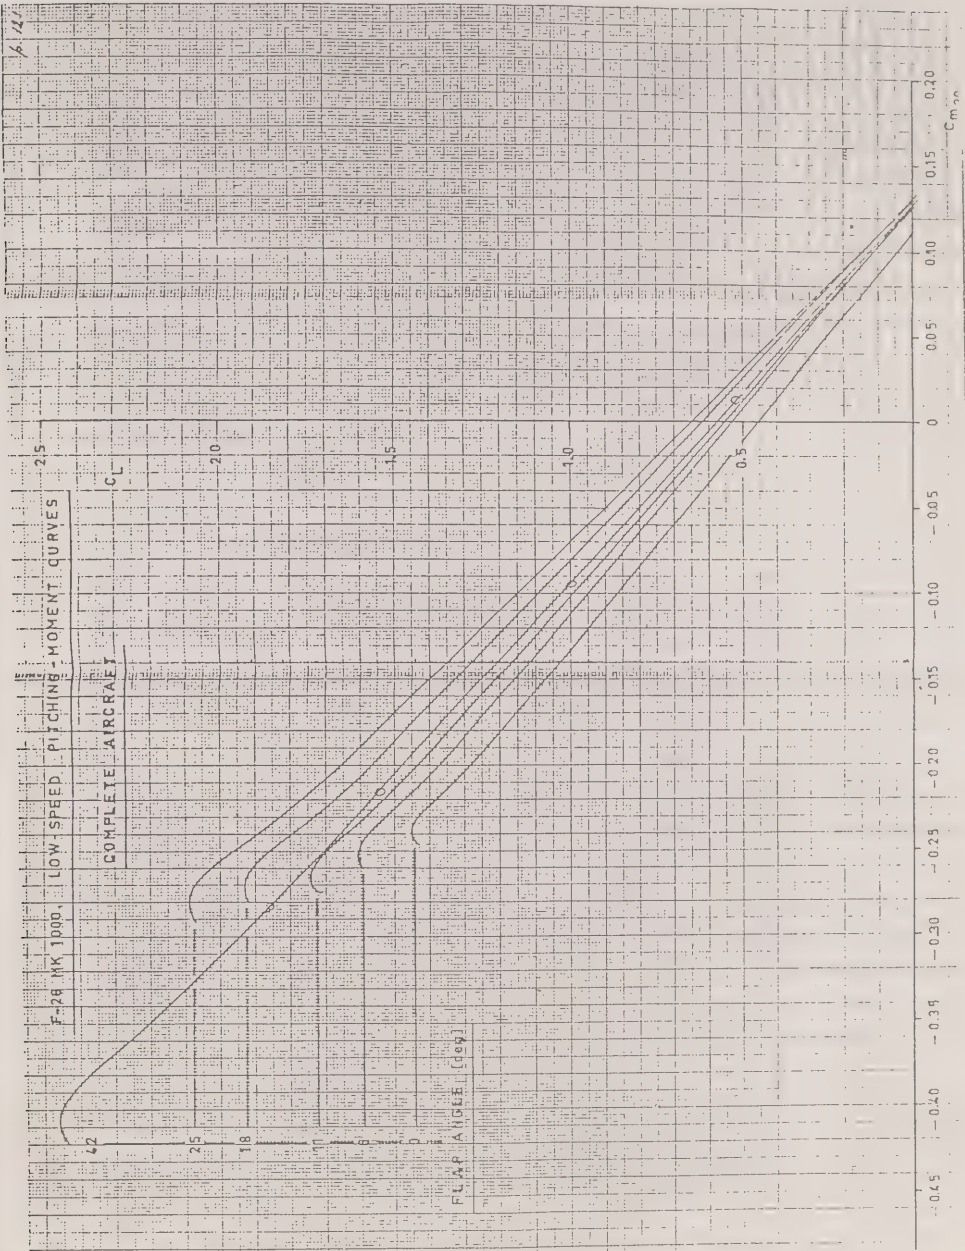
FIGURE 12 F-28 MOMENT COEFFICIENT vs LIFT COEFFICIENT (FREE AIR)

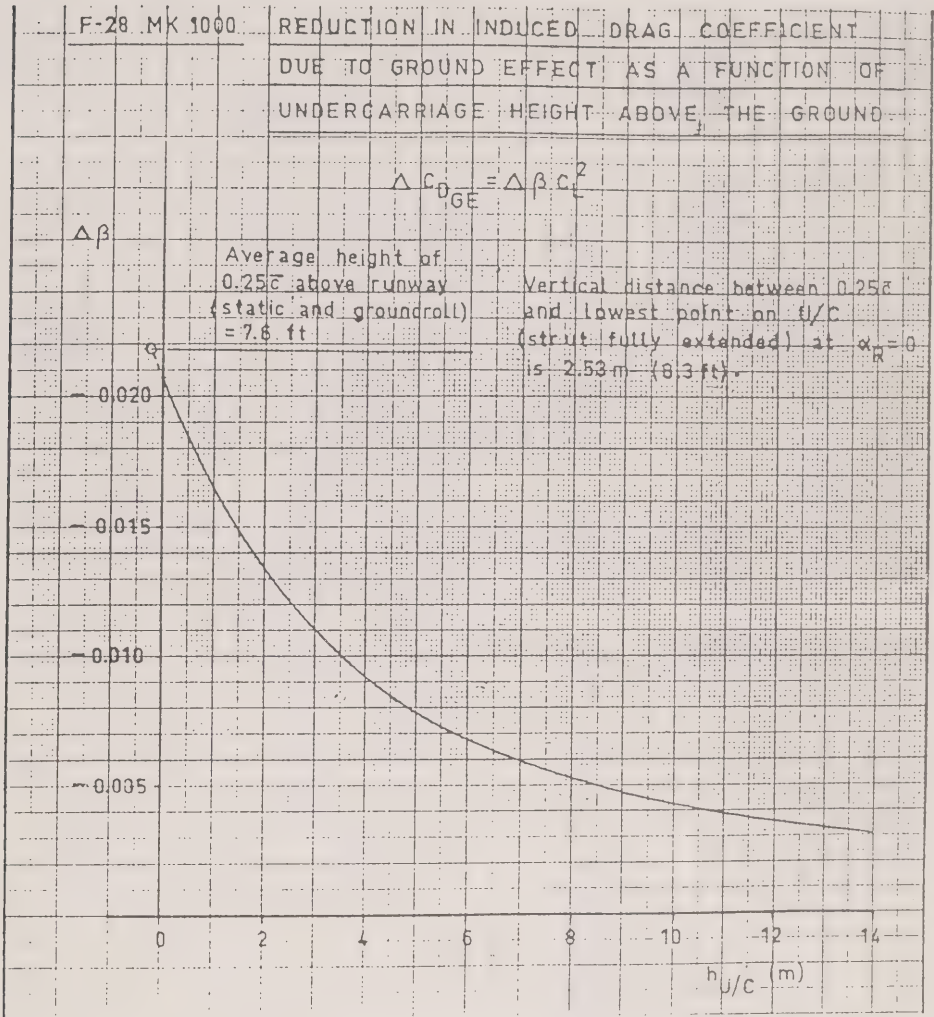
FIGURE 17 CHANGE IN INDUCED DRAG DUE TO GROUND EFFECT

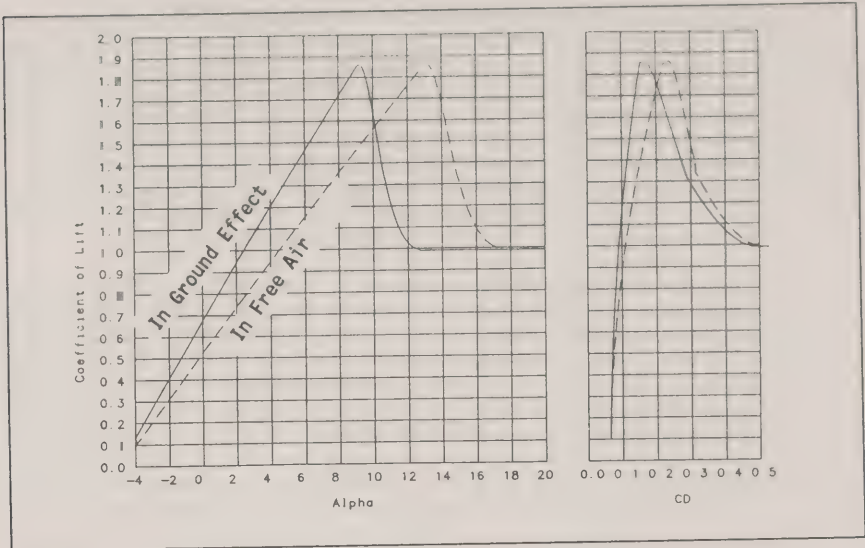
Figure 2:  $C_L$  and  $C_D$  for Clean Wing

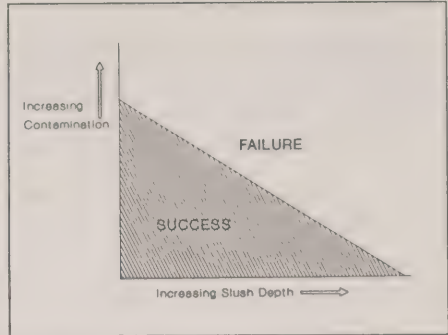
Figure 3: A Boundary Condition Plot

contamination and runway slush depth which represents the dividing line between a successful take-off or not, as illustrated in Figure 3. In both Figures 6 and 7, several boundaries are shown for varying conditions of  $V_r$  and rotation rate, these should be individually interpreted according to Figure 3.

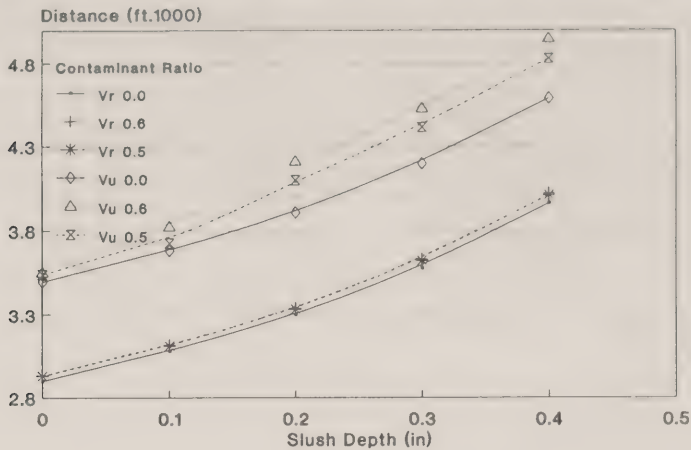
Figure 4 Effect of Contamination and Slush on the Distance Required to Reach  $V_r$  and  $V_u$

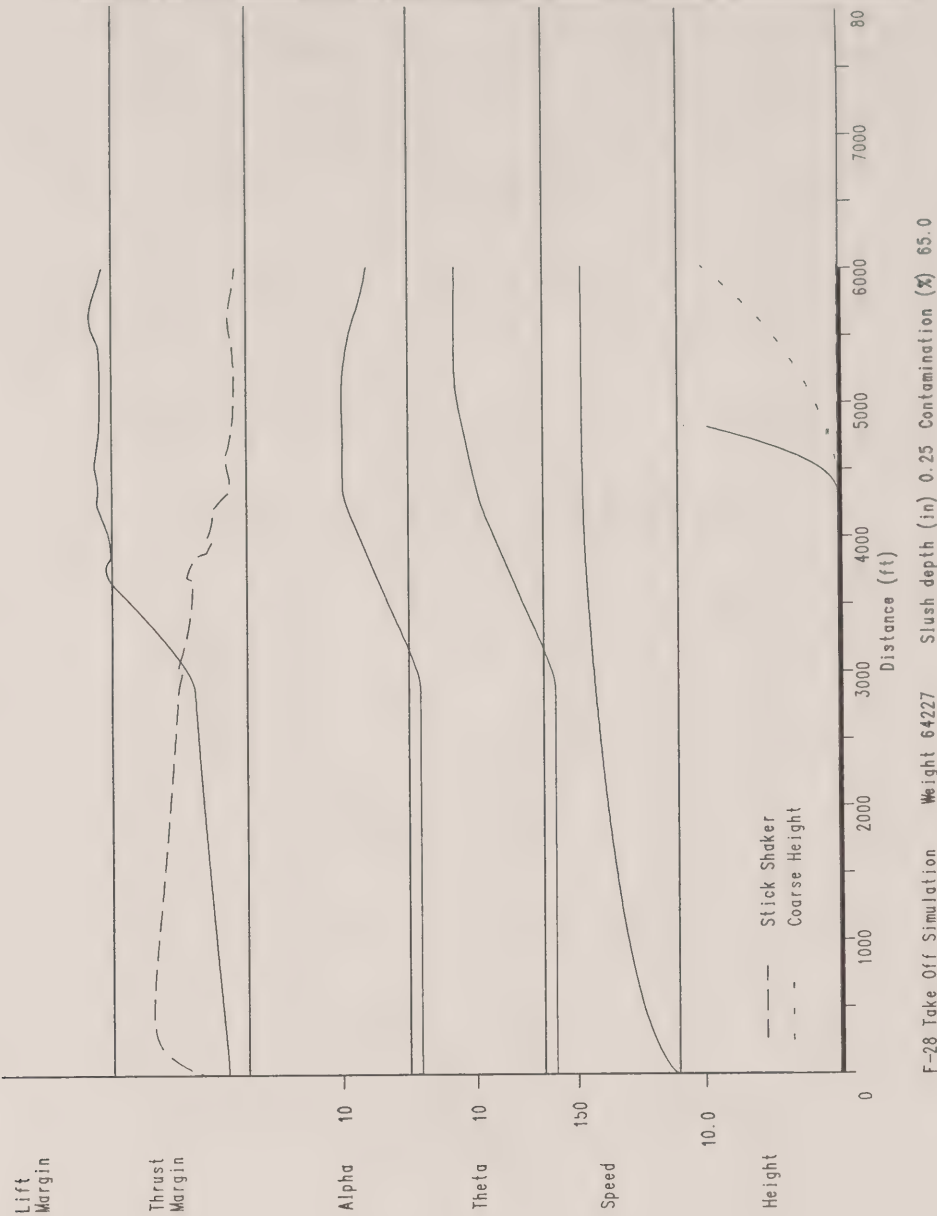
Figure 8a Successful Take-Off

The final sets of Figures provided with this section are intended to illustrate the effects and observations made earlier in the text. Figure 8, a,b and c shows the overall effects of increasing contamination factor in a gross way. The rotation speed here was 122.5 kt and slush depth 0.25 in. At 65% contamination the aircraft flies away normally, at 68% the machine sinks following the initial lift off, due both to the loss of lift with height and the pilot's reaction to stick shaker, but then climb away. Note that the scale of the height trace is such that at 6500 feet (500 feet beyond the end of the runway) the aircraft is still only at 10 feet. In 7c, contamination now being set at 69% the aircraft returns to the runway and subsequently runs off the end. The series in Figure 9 a,b and c shows that fine graduation of the contaminant level creates subtle differences in the aircraft responses. This set of plots refers to a much shallower slush layer (0.1 in) and an incremented rotation speed of 127.5 kt. Figure 9a indicates that at 82.3% contamination the aircraft flies away despite two bursts of stick shaker, while by the time contamination is at 82.4% the machine never exceeds about 5 ft, eventually returning to the surface some 1100 feet beyond the end of the runway. When there is 0.1% additional contamination the result is a short hop and an over-run. Finally, Figure 10 a and b demonstrate the remarkable sensitivity to assumed pilot behaviour noted earlier. The only difference in these two runs is that the angle to

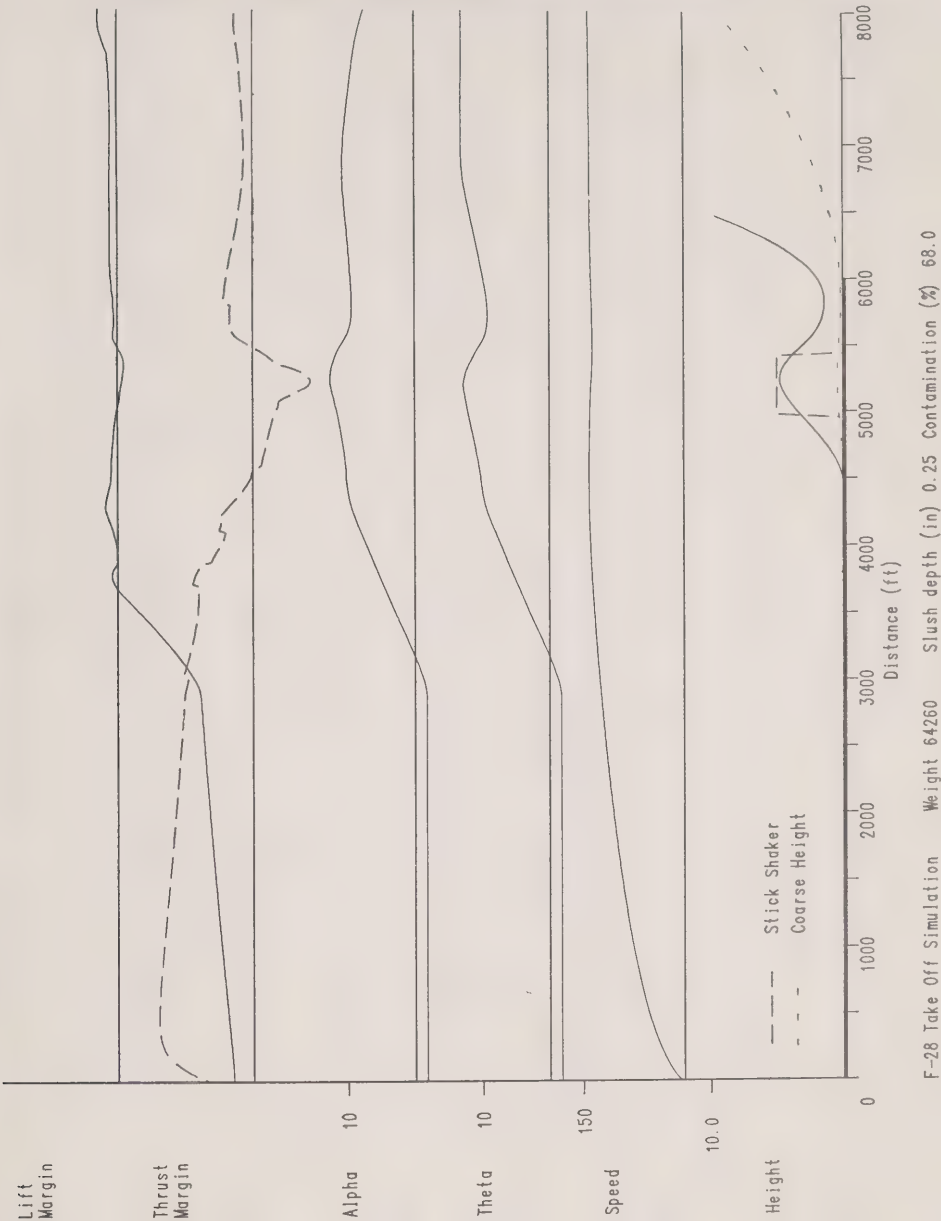
Figure 8b Marginal Take-Off

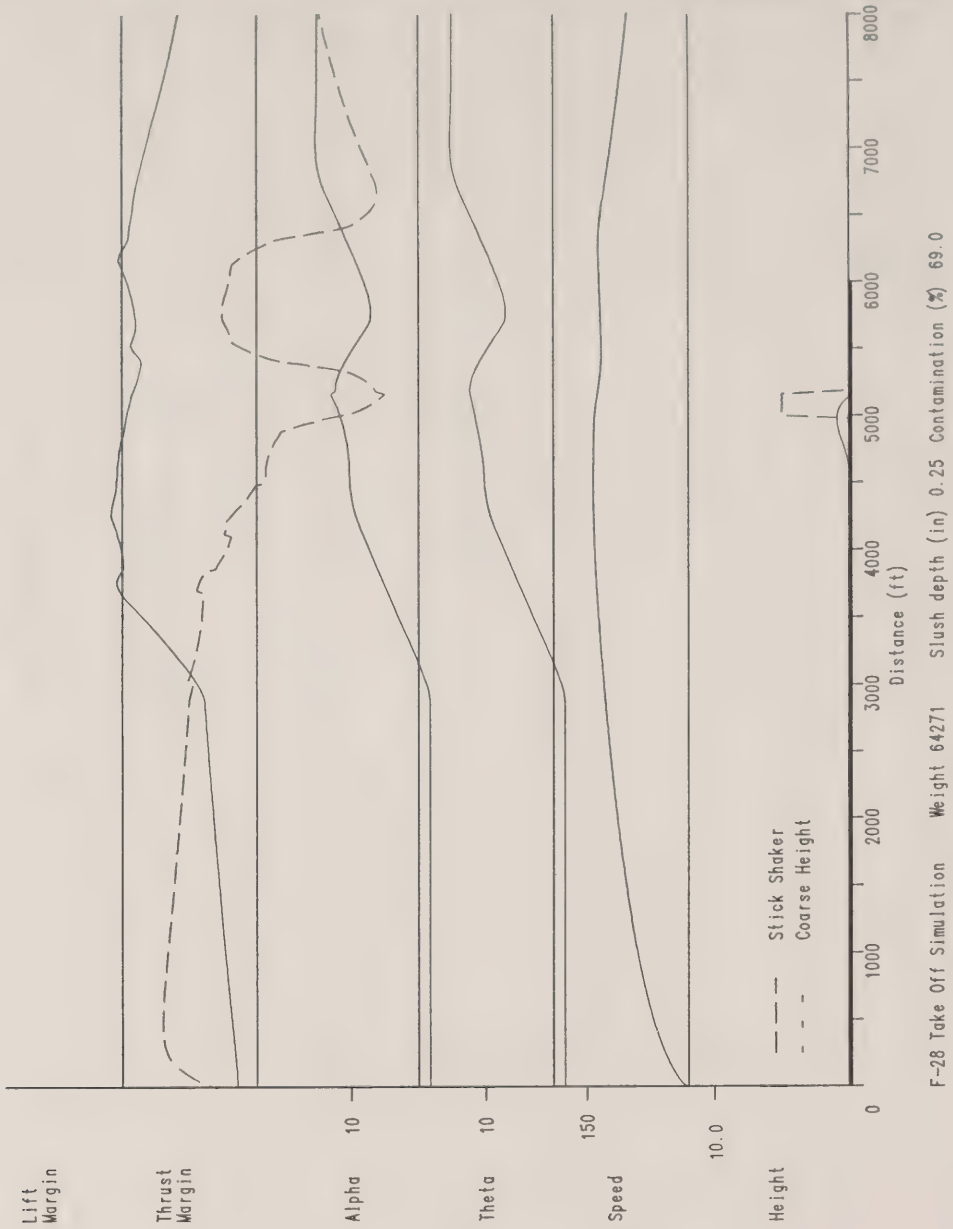
Figure 8c Unsuccessful Take-Off

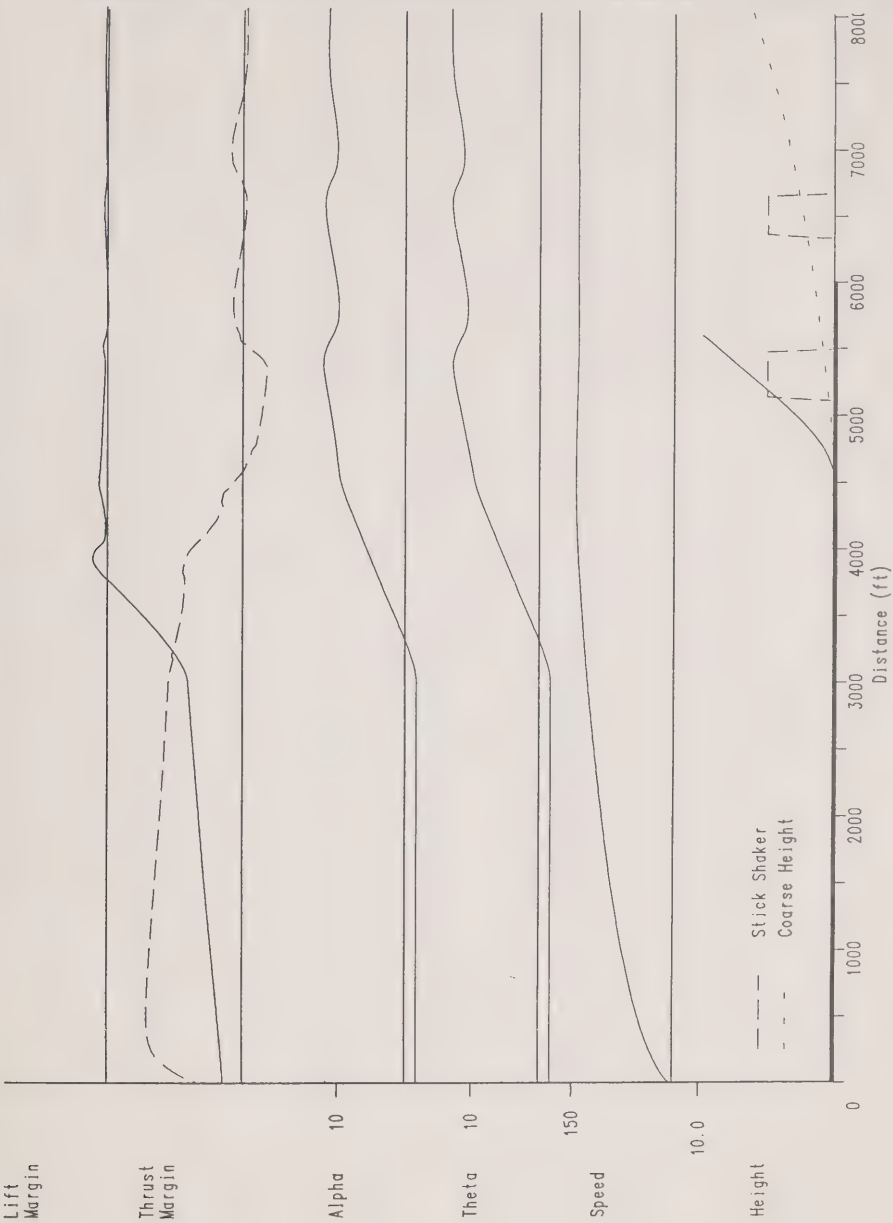
F-28 Take Off Simulation Weight 64420 Slush depth (in) 0.10 Contamination (%) 82.3

Figure 9a Successful Take-Off at 82.3% Contamination

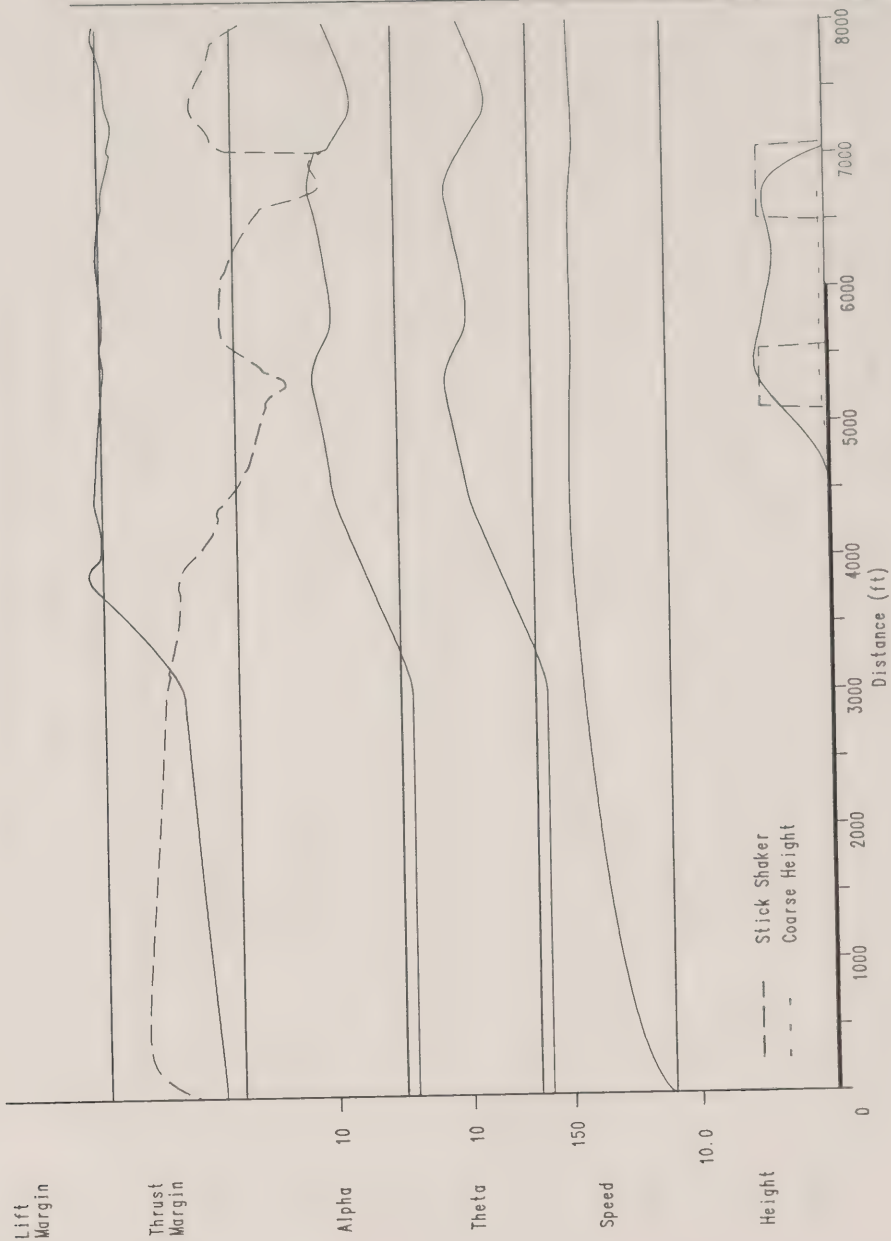
F-28 Take Off Simulation Weight 64421 Slush depth (in) 0.10 Contamination (%) 82.4  
Figure 9b Unsuccessful Take-Off at 82.4 % Contamination, Identical Technique  
The Aircraft Flew over 2400 feet before Crash

which the aircraft is un-rotated following the initial hop is two degrees lower in 9b than 9a, the latter strategy resulting in a second lift-off and climb out and this at a very high level of contamination.

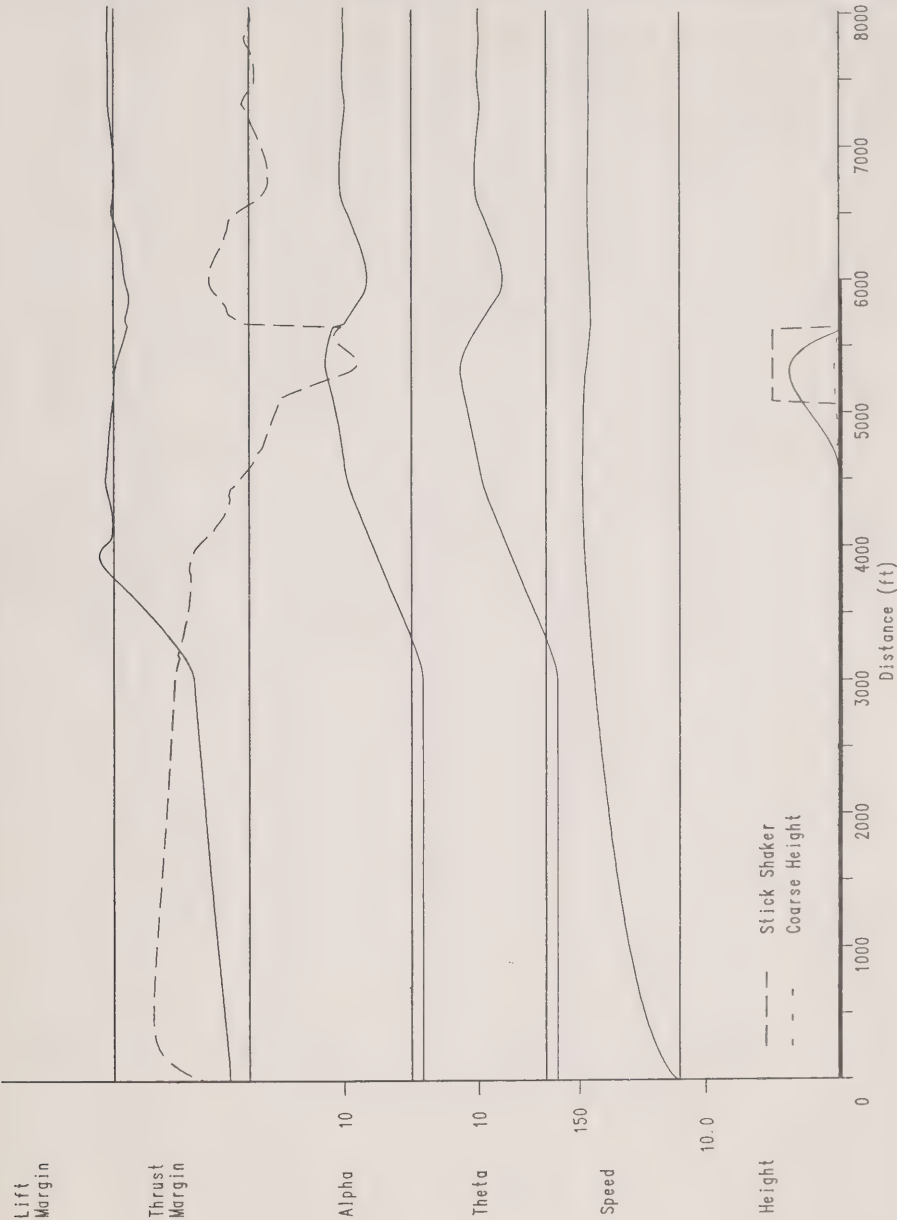
F-28 Take Off Simulation Weight 64422 Slush depth (in) 0.10 Contamination (%) 82.5

Figure 9c At 82.5% Contamination the Take-Off Becomes a Short Hop and Runway Overrun
